Use Of Geosynthetics In Dams

BUREAU OF RECLAMATION EXPERIENCES WITH GEOMEMBRANES IN DAM CONSTRUCTION

W. R. Morrison¹, E.W. Gray Jr.,¹ J. M Cyganiewicz,¹ and P. G. Grey¹

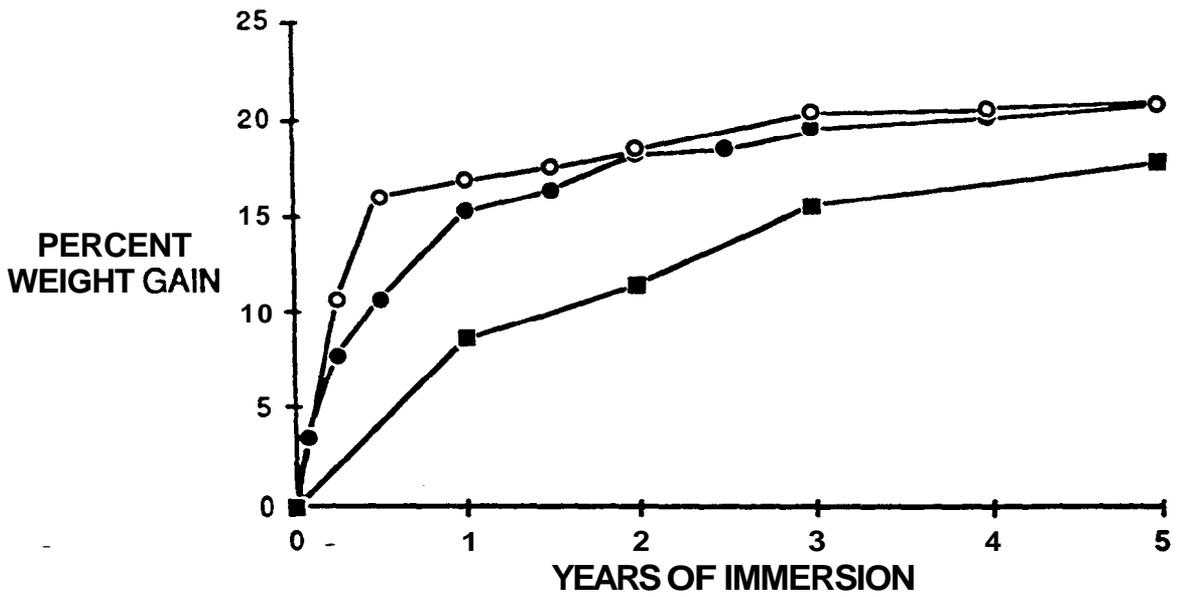
Test results conducted on random samples of the 1.14-mm CPER during the 5-year laboratory water immersion period are summarized in table 6. The testing of sealed versus unsealed edges showed no major differences in mechanical properties due to possible water wicking through the exposed scrim. Consequently, only the test results for the specimen with unsealed edges are presented in table 6. The results generally paralleled those observed for the field samples. The moisture absorption for the laboratory immersion samples leveled off around 21 percent as shown in figure 4.

FIGURE 4. MOISTURE ABSORPTION - LABORATORY WATER IMMERSION TESTING AND MT. ELBERT TEST SECTION RESULTS

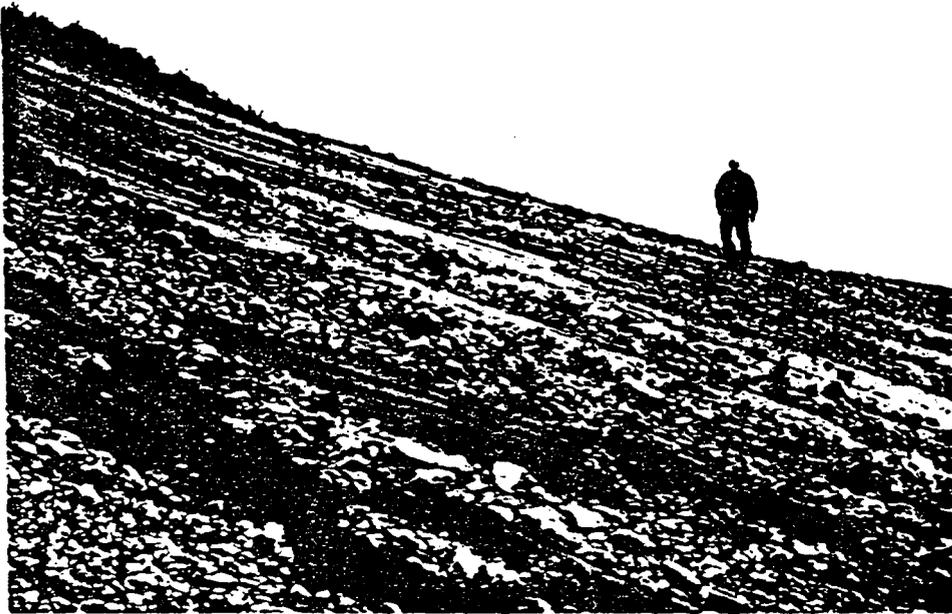
In February 1986, unusually heavy rainfall occurred in the reservoir. During and immediately following the rainfall event, slippage of portions of the earthfill cover occurred. A total of eight separate areas experienced slippage affecting 4 hectares of cover material and exposing 1.2 hectares of geomembrane. Several areas experiencing slippage are shown in figures 12 and 13.

Figure 13. View showing exposed geomembrane after slippage of protective soil cover.

During the summer of 1987, a remedial construction program was initiated to repair the exposed areas of geomembrane (Reclamation-1987). Seven of the eight areas were repaired by sandblasting the top surface of the exposed liner to enhance the frictional resistance followed by covering it with a 0.15-m layer of pervious sand and gravel bedding and a 0.3-m layer of cobbles. Careful quality control ensured that there would be no damage to the geomembrane during sandblasting operations. For the remaining slide area, the existing geomembrane was removed and replaced with a texturized HDPE geomembrane and covered with bedding and cobbles.
