7<sup>th</sup> International Congress on Civil Engineering  
ICCE 2006  
Civil Eng. Dept., Tarbiat Modares Univ.  
May 8-10, 2006, Tehran, Iran

## **A STUDY ON FAILURE PATTERN OBSERVED IN MASONRY BUILDINGS DURING 8<sup>TH</sup> OCTOBER HAZARA-KASHMIR EARTHQUAKE IN PAKISTAN**

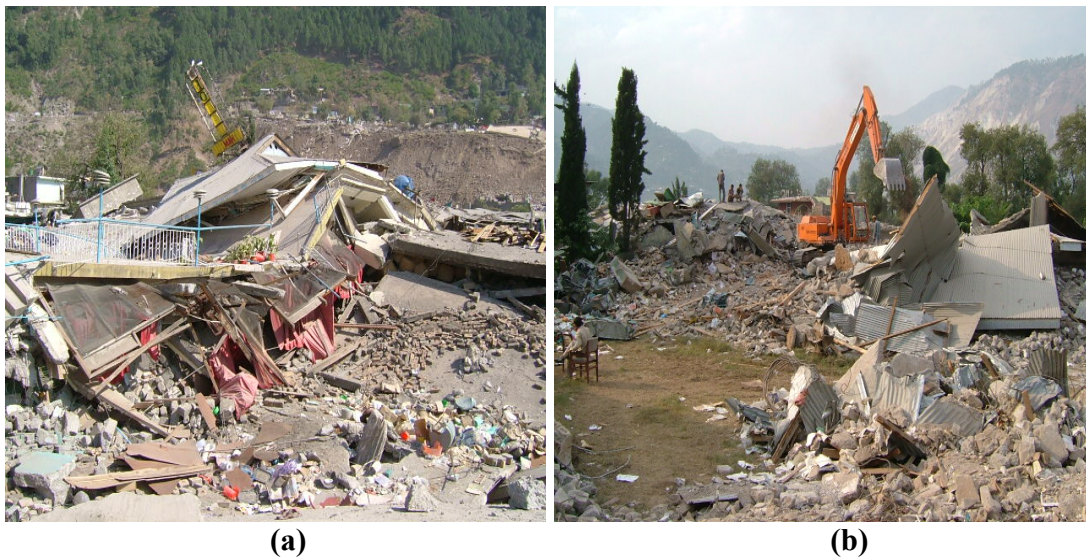
**Figure 2:** (a) View of devastating damages in Balakot  
(b) View of completely destroyed Muzaarabad University

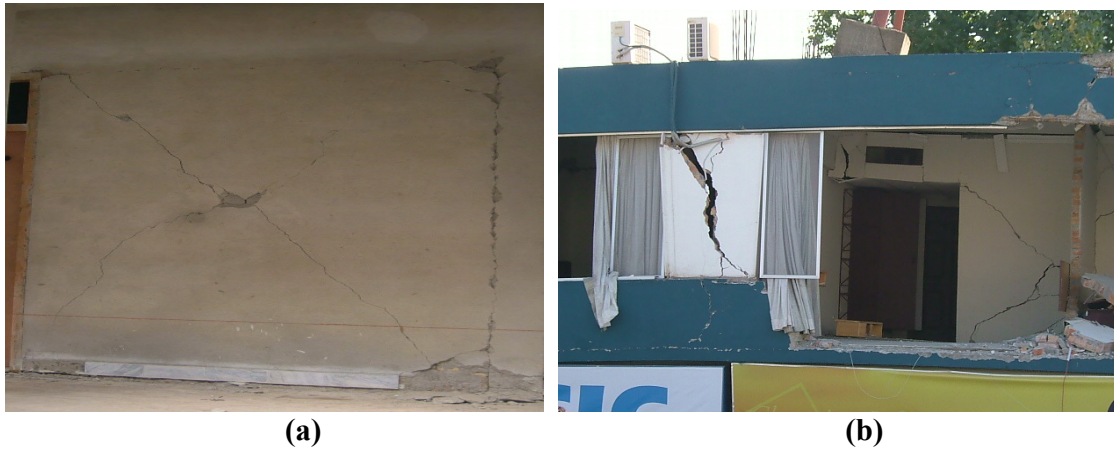
Shear cracks appeared in the load bearing and masonry infill due to severe ground motion during the earthquake. The load bearing members and masonry infill at the right angle to the direction of ground acceleration showed shear cracks due to accumulation of

shear stresses in the member. Fig.3a shows the shear cracks in load bearing wall as the wall was in the perpendicular direction with respect to earthquake motion. Fig.3b shows cracks in the masonry infill.

**Figure 3:** (a) Shear cracks in masonry load bearing wall (Muzaffrabad University)  
(b) Shear cracks in masonry infill in shopping plaza at Abbottabad

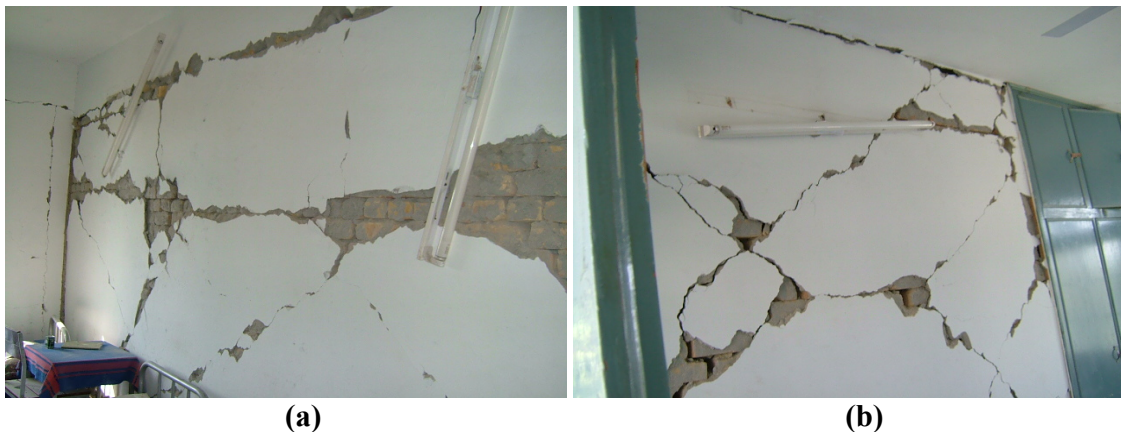
Flexural as well as shear cracks were observed in most of the building due to excessive stresses induced by in plane vertical and horizontal forces. As the affected area was very close to the fault surface the vertical and shear component of the seismic wave had combined significant affects on most of the buildings. Figure 4(a) & (b) shows the horizontal flexural and shear cracks in brick masonry load bearing wall due to in plane movement caused by earthquake vertical and horizontal forces.

**Figure 4:** (a) Flexural & shear cracks alongwith separation of wall from wall connection  
(b) Shear & flexural cracks alongwith separation of wall from roof

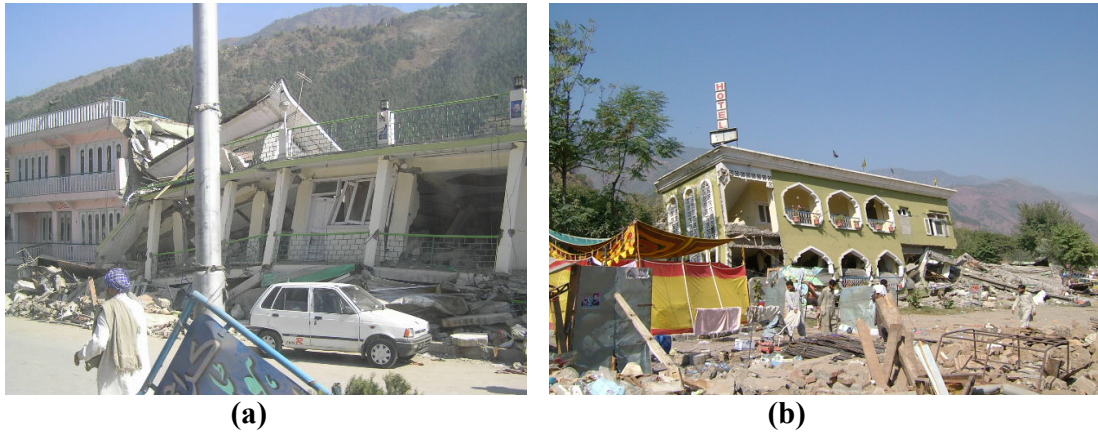
Failure of masonry structure was also observed due to settlement. Most of the buildings were constructed without any prior soil investigation and situation got worsened by constructing the structures on the fill land with shallow and improperly designed

foundation. In the eve of the catastrophic earthquake the earth shaking destabilized the soil beneath the structures and they collapsed. Figure 5(a) & (b) shows the collapse of brick masonry building due to settlement due to shear / settlement failure of soil beneath the foundation.

**Figure 5:** (a) Collapse of masonry building in Muzaffrabad due to settlement  
(b) Collapse of masonry building in Balakot due to settlement

5.3- It was observed during this visit that a number of masonry structures were damaged due slope failure and improper foundations. It is strongly recommended to carry out proper soil investigation and proper footing type according to soil investigation. Construction on unstable slopes should be avoided; otherwise it is necessary to stabilize the slope before constructing any structure. Mat/Raft foundation should be made mandatory for residential buildings or pile foundations and unstable slopes will be the most appropriate solution.

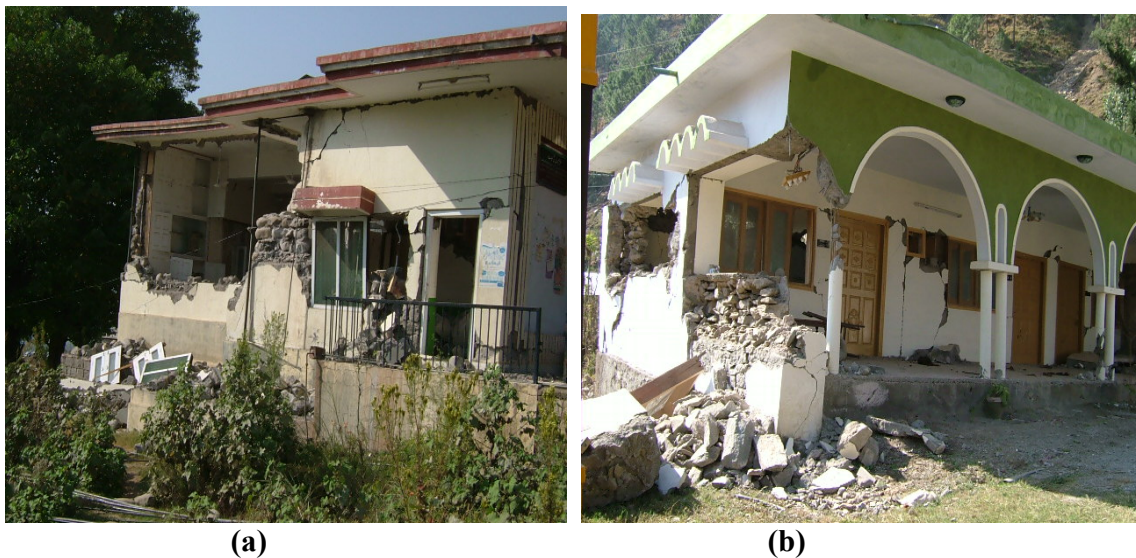
Collapse of buildings due to out of plane movement was also observed in the affected areas. All the walls having less flexural strength and minimum stiffness in the perpendicular direction of seismic waves were collapsed causing the failure of complete structure. Figure 6(a) & (b) shows the collapse of load bearing stone masonry wall due to out plane earthquake forces.

**Figure 6:** (a) & (b) Collapse of load bearing wall due to out of plane loading
